Robe

Marina Entrance Position

Robe Marina

Lake Butler, Robe, South Australia

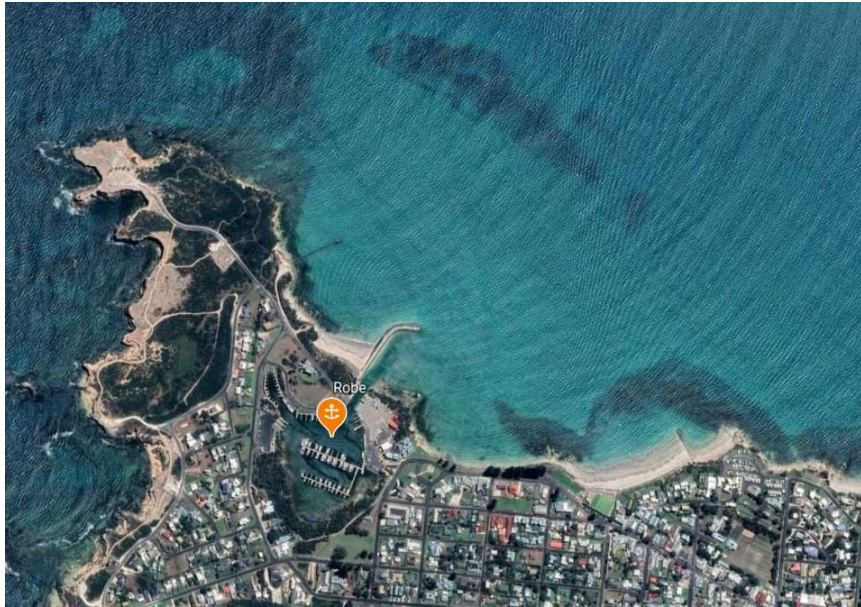
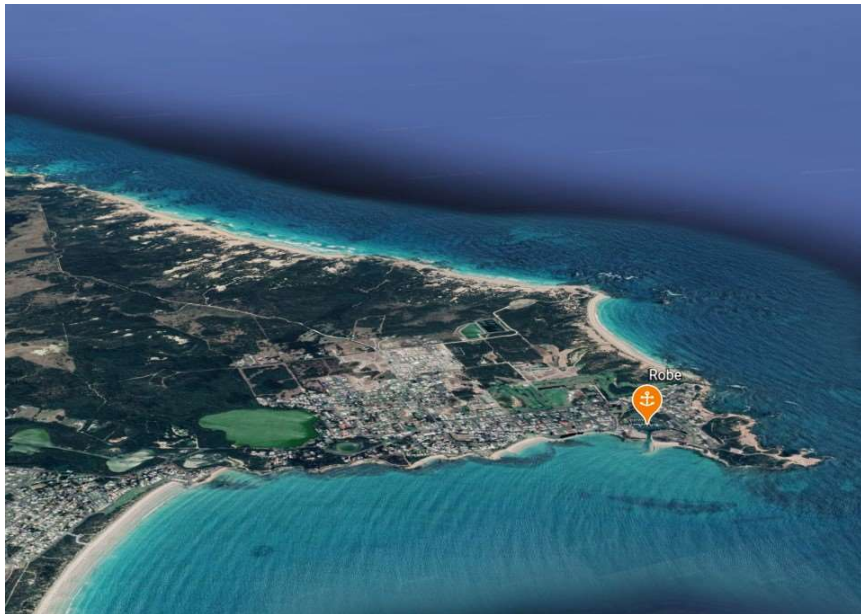
A plan of the marina is attached and visiting yachts are generally allocated to berths on the 'Karatta Moorings' on the northern side. A fuel berth with 24 hour credit card access is located on the eastern side.

On a cautionary note, the entrance channel to marina is subject to silting, and both the depth and position of shoaling may change, so entry may not be possible at certain tides. Current advice should always be sought from the local council before attempting entry. The council can be contacted on 08 8768 2003. A full description of the marina facilities is available on the council website (<https://www.robe.sa.gov.au/services/lakebutlermarina>).
